# Condition report and service proposal

Halfaker Residence  
8159 Entrada De Luz E, San Diego, CA 92127

Inspection: August 11, 2026 | Prepared: August 11, 2026 | Valid through: August 26, 2026

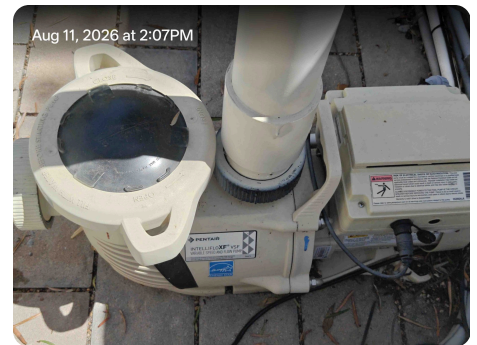
Pump P-2: Pentair IntelliFloXF VSF variable-speed and flow pump.

| ID | EQUIPMENT | ASSESSMENT | SERVICE APPROACH |
|---|---|---|---|
| P-2 | Pentair IntelliFloXF VSF variable-speed and flow pump | High-quality variable-speed and flow pump. Heavy algae was present in the basket, which points to an active maintenance or circulation issue in this path. | Clean and sanitize the basket and housing, then verify prime, flow, assigned circuit, and programmed run time. |

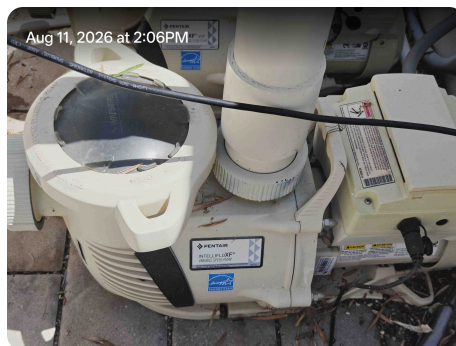
Pump P-1: Pentair IntelliFloXF variable-speed pump.

| ID | EQUIPMENT | ASSESSMENT | SERVICE APPROACH |
|---|---|---|---|
| P-1 | Pentair IntelliFloXF variable-speed pump | Premium high-flow variable-speed platform. Heavy algae was present in the basket, indicating the affected water path needs cleaning and circulation review. | Remove organic material, clean and sanitize the basket and housing, then verify prime, flow, speed assignment, and schedule during the baseline visit. |

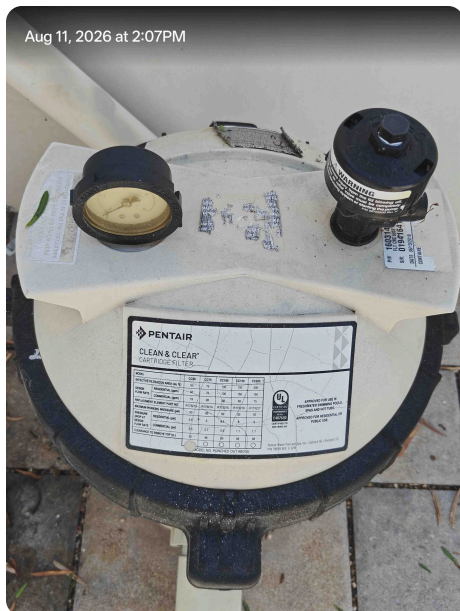
Filter F-2: Pentair Clean & Clear CC50, manufactured June 2019.

| ID | EQUIPMENT | ASSESSMENT | SERVICE APPROACH |
|---|---|---|---|
| <b>F-2</b> | Pentair Clean & Clear CC50, part 160314, manufactured 06/12/2019 | Compact cartridge filter suited to a dedicated fountain or auxiliary circuit. Leakage is present at a union and the cartridge may be aging. | Repair the leaking union, clean and inspect the cartridge, record clean pressure, and confirm the filter's assigned body of water. |

Recommended only if the existing cartridge fails inspection or does not recover acceptable pressure and flow after cleaning.

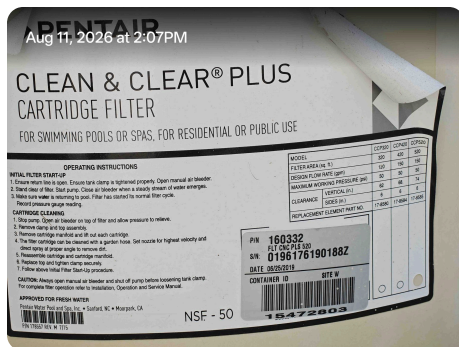
Filter F-1: Pentair Clean & Clear Plus CCP520, manufactured June 2019.

The two dated filter vessels were manufactured in 2019. Cartridge condition cannot be judged from vessel age alone, but replacement should be anticipated if the cartridges are original, damaged, or no longer recover normal pressure after cleaning.

| ID | EQUIPMENT | ASSESSMENT | SERVICE APPROACH |
|---|---|---|---|
| <b>F-1</b> | Pentair Clean & Clear Plus CCP520, part 160332, manufactured 06/25/2019 | Large-capacity cartridge filter appropriately sized for a complex pool and spa system. The vessel is about seven years old and should be cleaned before cartridge condition is judged. | Open and clean the filter, inspect all four cartridges, record clean pressure, and replace the cartridge set only if damaged, deformed, or unable to recover performance. |

Recommended if the four cartridges are damaged, deformed, original to the 2019 filter, or cannot recover normal performance after cleaning. Confirm customer replacement history before authorizing.

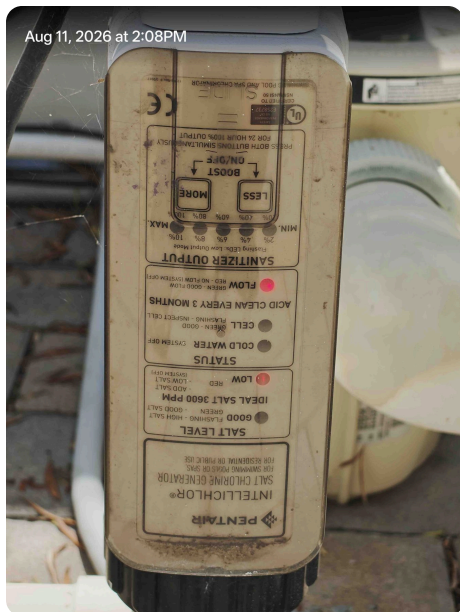
Sanitizer S-3: Pentair IntelliChlor salt chlorine generator.

The IntelliChlor displayed low-salt or flow indications and appears consistent with the age of the 2019 equipment. Clean and test the cell first. If output remains inadequate, the correctly sized replacement is a Pentair IntelliChlor Plus40.

| ID | EQUIPMENT | ASSESSMENT | SERVICE APPROACH |
|---|---|---|---|
| <b>S-3</b> | Pentair IntelliChlor salt chlorine generator | Integrated salt-chlorine system showing low-salt or flow indications. Based on the surrounding 2019 equipment, the cell may be near the end of a typical service life if it has not already been replaced. | Clean and test the cell, verify salinity and flow, and replace only if it cannot produce adequate chlorine. The quoted replacement is the correctly sized IntelliChlor Plus40. |

Remove and clean the IntelliChlor cell, verify salinity and adequate flow, reinstall it, and test chlorine-production status. Replacement is not included in this item.

Recommended only if cleaning and testing show that the existing cell cannot produce adequate chlorine. Includes the correctly sized Plus40 cell, installation, configuration, salinity verification, and commissioning.

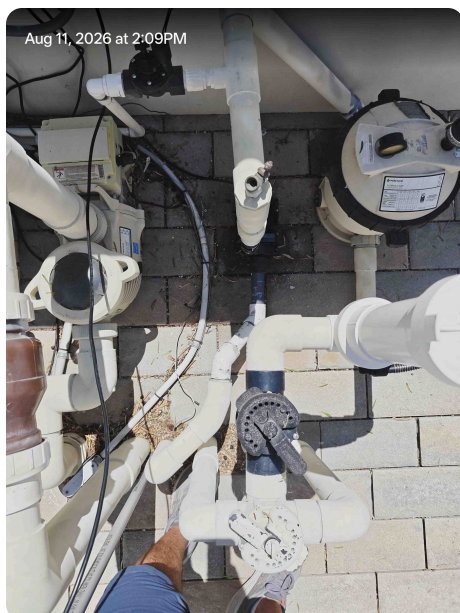
Active leakage was observed at a union connection. The union will be opened, inspected, resealed, and replaced if the sealing surfaces or fitting are damaged.

Leak 1 at a union connection.

Open the leaking union, inspect and clean the sealing surfaces, install the appropriate seal or fitting as needed, reassemble, and pressure-test the connection.

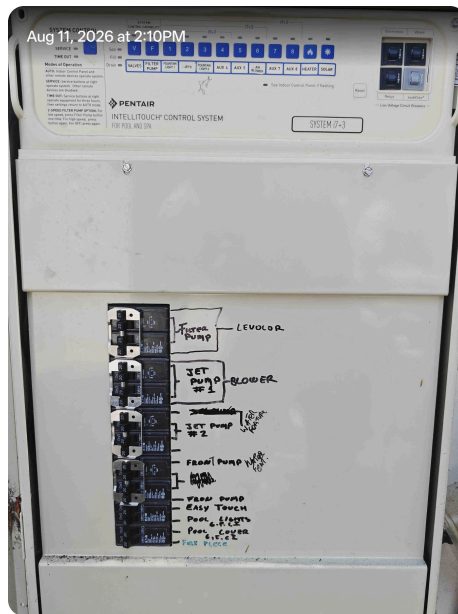
The existing IntelliTouch system is an established but older automation platform. An IntelliCenter i10PS upgrade would add a current user interface, app-based remote control, easier scheduling and diagnostics, and a supported platform for future equipment integration. This is optional and not required to begin service.

| ID | EQUIPMENT | ASSESSMENT | SERVICE APPROACH |
|---|---|---|---|
| <b>A-1</b> | Pentair IntelliTouch i7+3 automation | Capable but older-generation automation with substantial circuit capacity. It can remain in service if controls, relays, and programming perform correctly. | Document circuit assignments, verify relays and valves, optimize schedules, and retain unless reliability or remote-control needs justify the optional IntelliCenter upgrade. |

Pentair IntelliTouch i7+3 automation control center.

Optional modernization from IntelliTouch to a current IntelliCenter platform with an updated interface, app-based remote access, easier schedules, clearer status and diagnostics, and a supported base for future integrations. Existing equipment remains subject to compatibility verification.

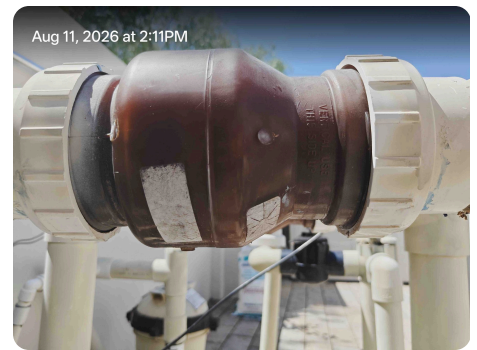
Leakage was observed at the large swing check valve. Service includes opening and inspecting the valve, replacing serviceable seals or internal parts when practical, and replacing the valve if needed within the quoted scope.

Leak 3 at the large 4-inch swing check valve.

Open and inspect the union-style 4-inch swing check valve, replace serviceable seals or internal parts when practical, and replace the complete valve if needed. Restore circulation and verify the repair under operating pressure.

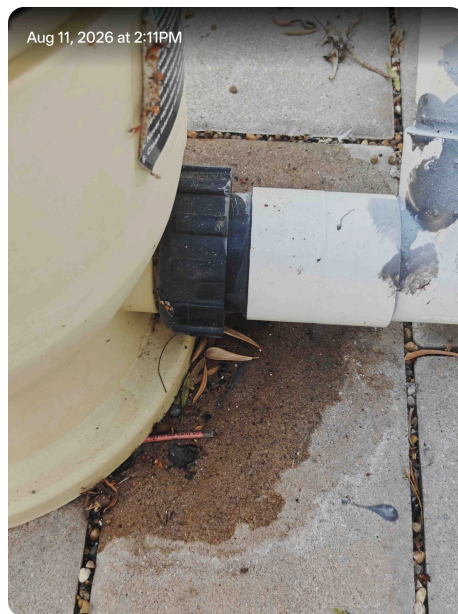
Leakage was observed at a union serving the smaller Clean & Clear filter. The connection should be opened and rebuilt with the correct seal or fitting as needed.

Leak 2 at the smaller Clean & Clear filter union.

Open and rebuild the leaking filter union with the correct seal or fitting as needed, then restore circulation and verify the repair under pressure.

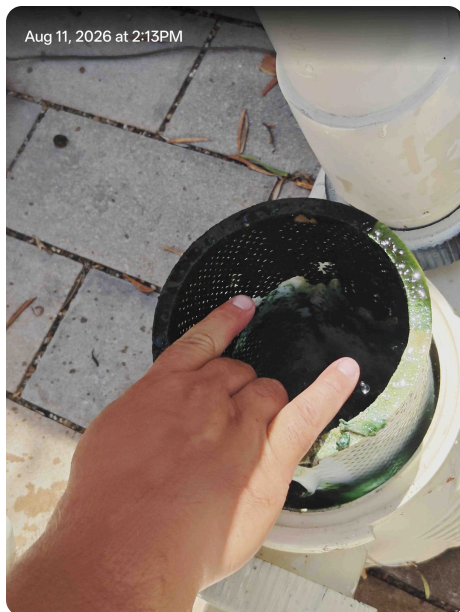
Substantial algae was found inside the baskets of Pumps 1 and 2. This suggests stagnant organic load or inadequate circulation in the affected paths and should be corrected before the property baseline is accepted.

Visible algae and organic accumulation in an affected pump basket.

Remove the visible algae and organic debris from Pumps 1 and 2, clean and sanitize each basket and accessible housing, restore prime, and verify circulation through the affected water paths.

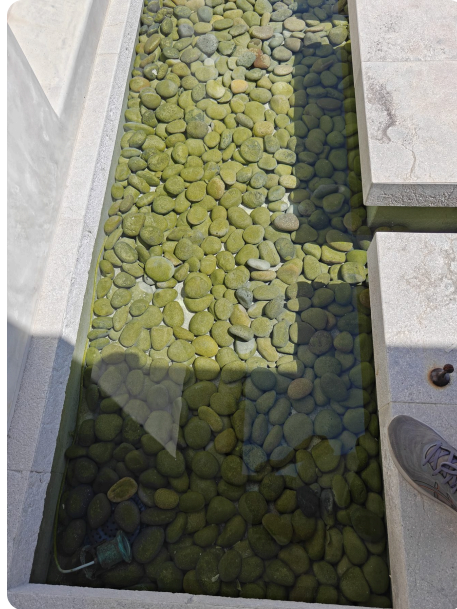
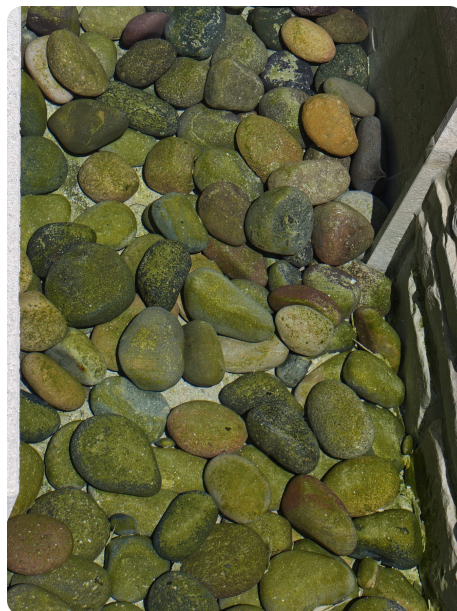
The front tiered fountain has excessive visible algae on the submerged stone and basin surfaces. BlueLux recommends brushing and a targeted treatment. As far as we can determine from the initial assessment, draining should not be necessary.

Front tiered fountain with visible algae across submerged stone.

Closer view of algae on the front tiered fountain stone.

Brush accessible submerged surfaces, apply a targeted algae treatment, circulate the treated water, and return to evaluate the response. As far as we can determine at the moment, draining is not required.

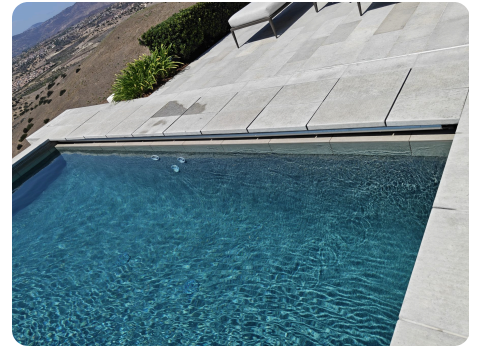
A visible calcium line remains along portions of the pool waterline. It is not critical to operation, but it is documented as an existing cosmetic condition and can be addressed separately if desired.

Pool overview showing the existing calcium line at the waterline.
