# Condition report and service proposal

Halfaker Residence  
8159 Entrada De Luz E, San Diego, CA 92127

Inspection: August 11, 2026 | Prepared: August 11, 2026 | Valid through: August 26, 2026

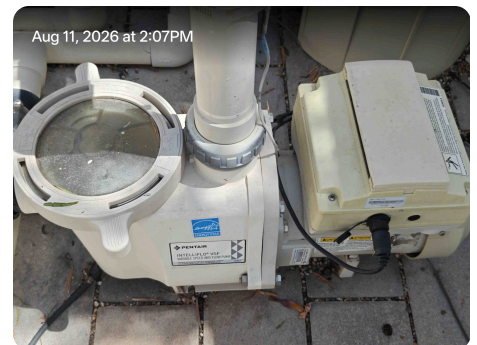
| ID | EQUIPMENT | ASSESSMENT | SERVICE APPROACH |
|---|---|---|---|
| P-3 | Pentair IntelliFlo VSF variable-speed and flow pump | Modern, efficient pump platform suited to precise circulation control. No material defect was identified during the limited assessment. | Confirm prime, commanded speeds, flow response, circuit assignment, and schedule during the functional baseline. |

Pump P-3: Pentair IntelliFlo VSF variable-speed and flow pump.

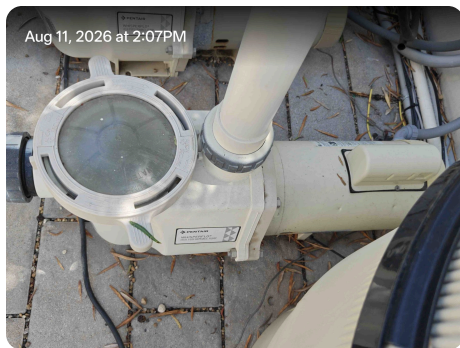
| ID | EQUIPMENT | ASSESSMENT | SERVICE APPROACH |
|---|---|---|---|
| P-4 | Pentair WhisperFlo High Performance pump | Established single-speed pump design commonly used for dedicated water features or auxiliary circulation. Exterior condition appears serviceable. | Confirm the served feature, motor sound, prime, flow, and valve path during the baseline. |

Pump P-4: Pentair WhisperFlo High Performance pump.

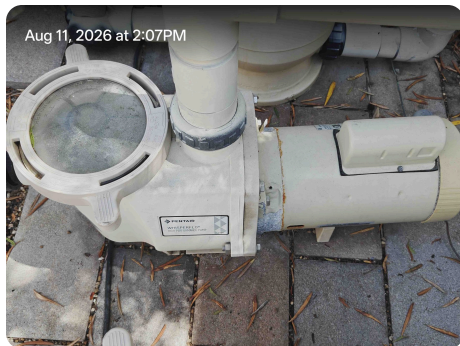
| ID | EQUIPMENT | ASSESSMENT | SERVICE APPROACH |
|---|---|---|---|
| <b>P-5</b> | Pentair WhisperFlo High Performance pump | Established single-speed auxiliary pump. It appears serviceable from the initial inspection, but its exact feature assignment and delivered flow were not fully tested while the property was in use. | Operate the assigned feature, listen for abnormal motor or bearing noise, inspect for seal leakage, and confirm that the pump primes and produces expected flow. |

Pump P-5: Pentair WhisperFlo High Performance pump.

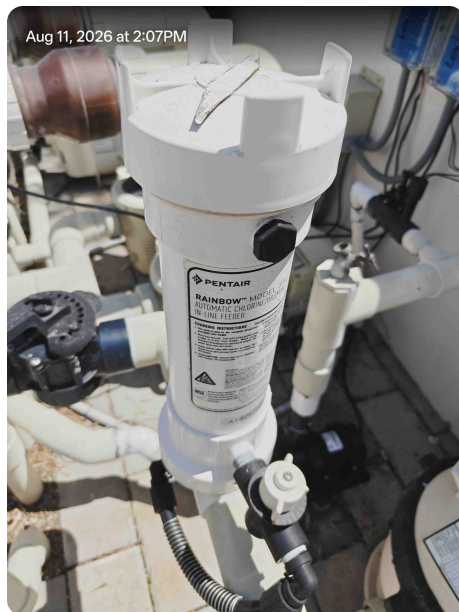
| ID | EQUIPMENT | ASSESSMENT | SERVICE APPROACH |
|---|---|---|---|
| <b>S-1</b> | Pentair Rainbow Model 320 in-line chlorinator | Established tablet chlorinator design. Exterior condition appears serviceable, but feed rate and check-valve performance require operational verification. | Inspect lid seal, check valve, feed control, and circuit assignment before placing it into the routine service program. |

Sanitizer S-1: Pentair Rainbow Model 320 in-line chlorinator.

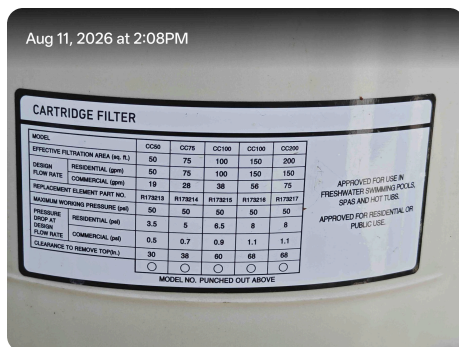
| ID | EQUIPMENT | ASSESSMENT | SERVICE APPROACH |
|---|---|---|---|
| <b>F-3</b> | Compact Pentair Clean & Clear cartridge filter, exact size not physically verified | Compact auxiliary filter of the same general equipment era. Exact size and cartridge condition remain to be established during the baseline. | Clean the filter, physically verify the model and cartridge, record clean pressure, and map it to the served fountain or circuit. |

Filter F-3: compact Pentair Clean & Clear cartridge filter.

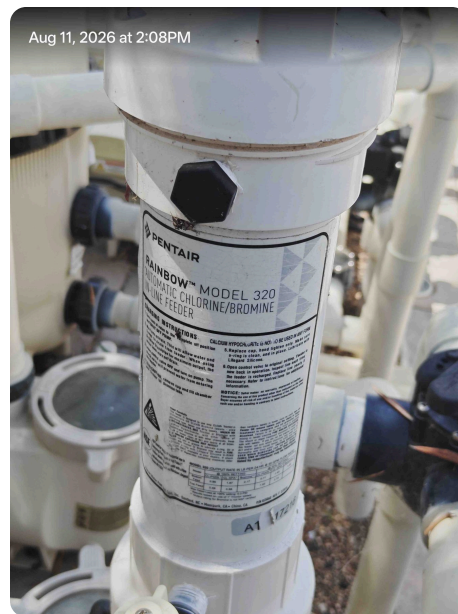
| ID | EQUIPMENT | ASSESSMENT | SERVICE APPROACH |
|---|---|---|---|
| <b>S-2</b> | Pentair Rainbow Model 320 in-line chlorinator | Second dedicated tablet chlorinator, likely serving an auxiliary body or circuit. Exterior condition appears serviceable. | Verify the served body, inspect the lid seal and check valve, and confirm controllable sanitizer delivery. |

Sanitizer S-2: second Pentair Rainbow Model 320 in-line chlorinator.

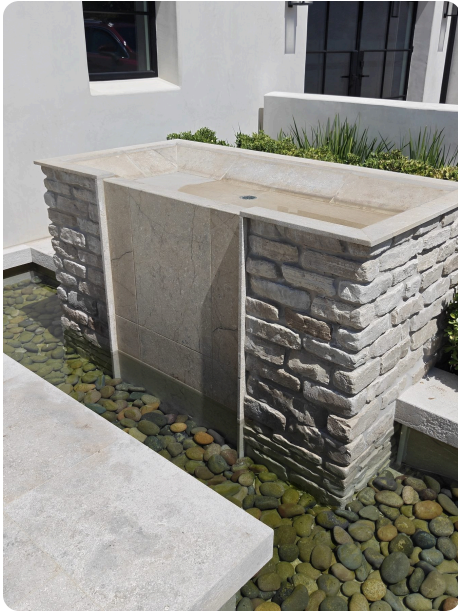
The front tiered fountain has excessive visible algae on the submerged stone and basin surfaces. BlueLux recommends brushing and a targeted treatment. As far as we can determine from the initial assessment, draining should not be necessary.

Front tiered fountain structure and lower basin.

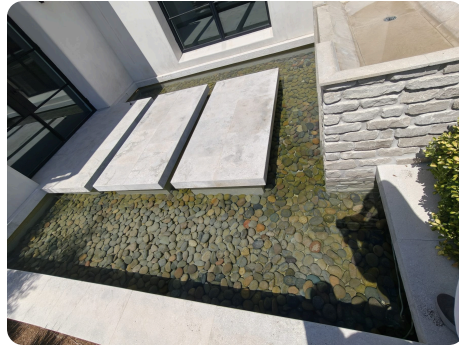
Front tiered fountain and surrounding water-feature system.

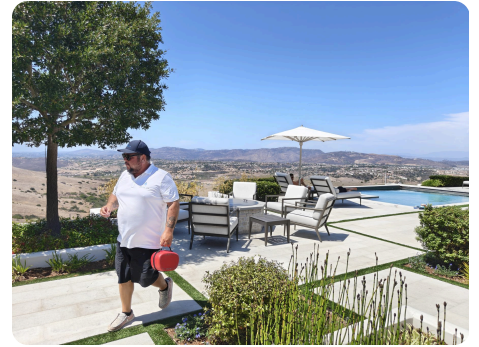
BlueLux technician at the pool terrace.

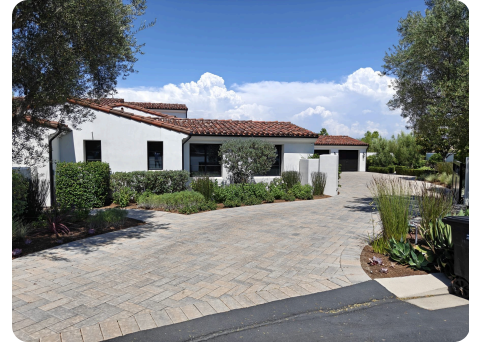
Halfaker Residence exterior.
